NSPS 0000a Annual Report

Oxy Permian Resources New Mexico Delaware Basin

Initial Reporting Period: 9/19/2015 – 8/2/2017

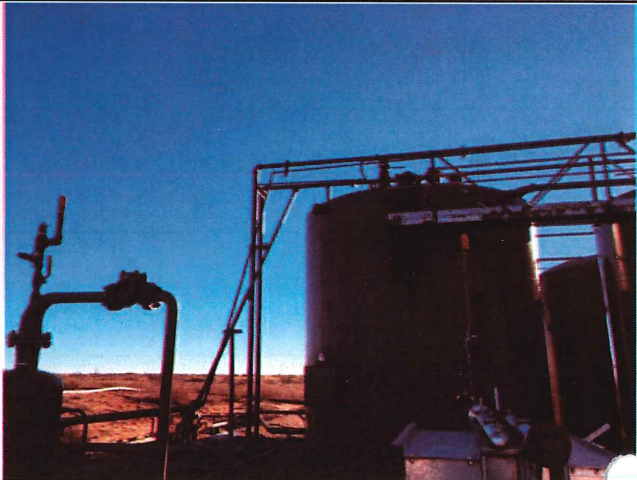
Type of Leaking Component?	Describe Leaking Component Location	Take iPhone photograph of leaking component and identify location.
Thief Hatch 60.5420a(b)(7)(vii) 60.5420a(b)(7)(viii)	Oil tank 1 Thief hatch or tank relief valve 60.5420a(c)(15)(ii)(l)(8)

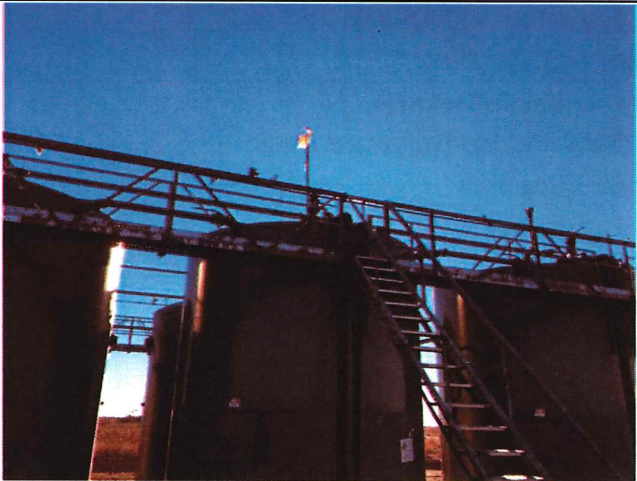
60.5420a(c)(15)(ii)(l)(8)
Pressure Safety Valve (PSV) 60.5420a(b)(7)(vii) 60.5420a(b)(7)(viii)	Oil tank 2 pressure relief safety valve behind thief hatch 60.5420a(c)(15)(ii)(l)(8)

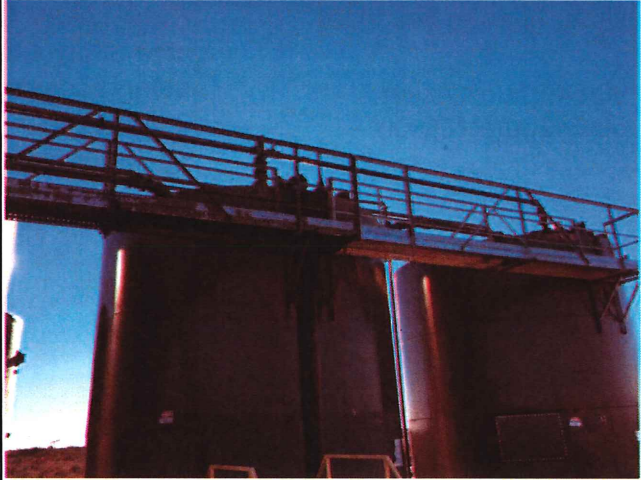
Type of Leaking Component?	Describe Leaking Component Location	Take iPhone photograph of leaking component and identify location.
Pressure Safety Valve (PSV) 60.5420a(b)(7)(vii) 60.5420a(b)(7)(viii)	Oil tank 3 pressure safety valve behind thief hatch 60.5420a(c)(15)(ii)(I)(8)

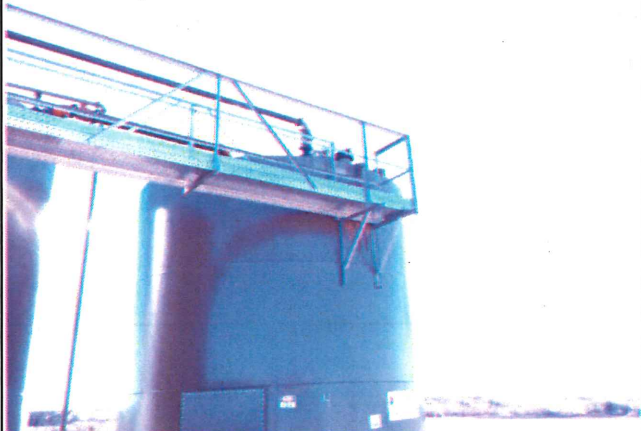
60.5420a(c)(15)(ii)(I)(8)
Pressure Safety Valve (PSV) 60.5420a(b)(7)(vii) 60.5420a(b)(7)(viii)	Oil tank 4 pressure relief valve behind thief hatch 60.5420a(c)(15)(ii)(I)(8)

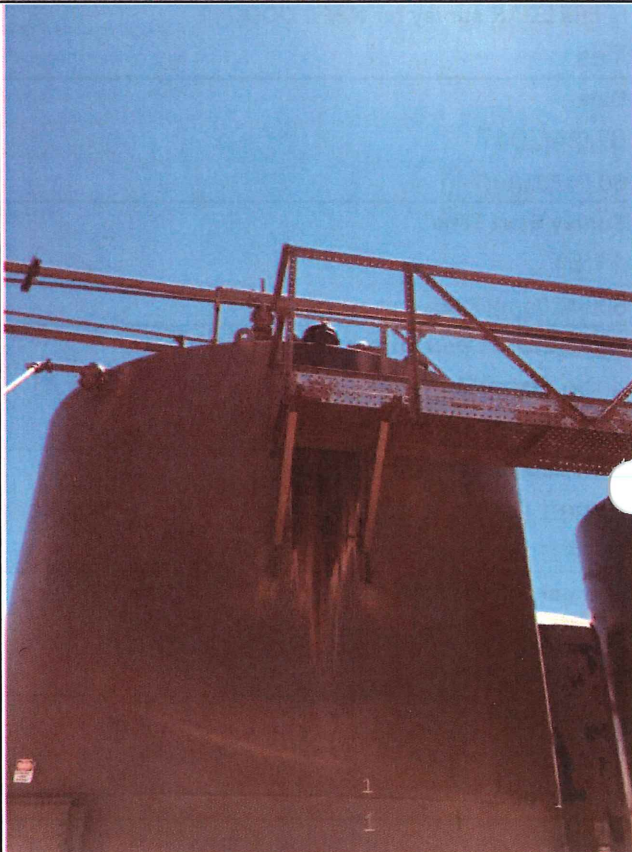
Type of Leaking Component?	Describe Leaking Component Location	Take iPhone photograph of leaking component and identify location.
Thief Hatch 60.5420a(b)(7)(vii) 60.5420a(b)(7)(viii)	Oil tank 1 thief hatch 60.5420a(c)(15)(ii)(l)(8)

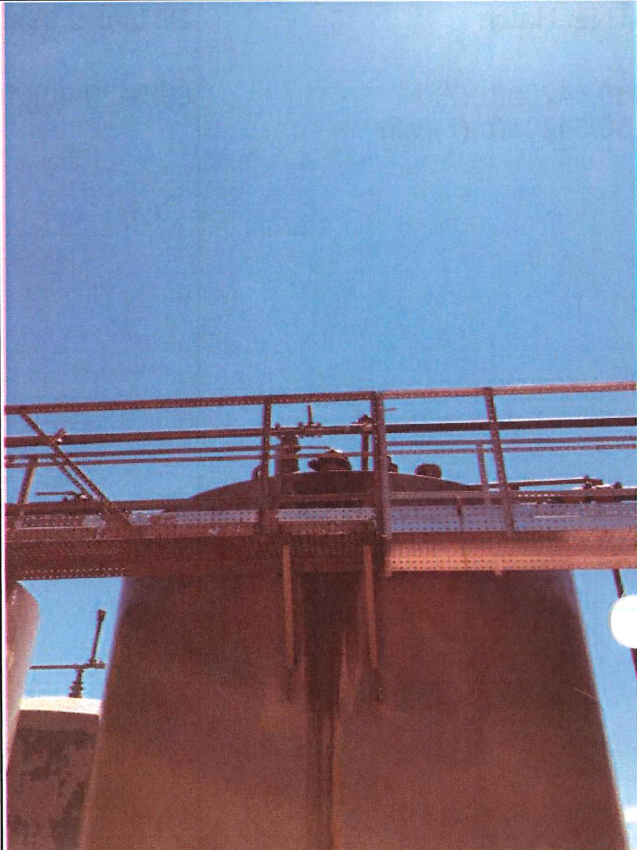
Type of Leaking Component?	Describe Leaking Component Location	Take iPhone photograph of leaking component and identify location.
Thief Hatch 60.5420a(b)(7)(vii) 60.5420a(b)(7)(viii)	Oil tank 2 thief hatch 60.5420a(c)(15)(ii)(l)(8)

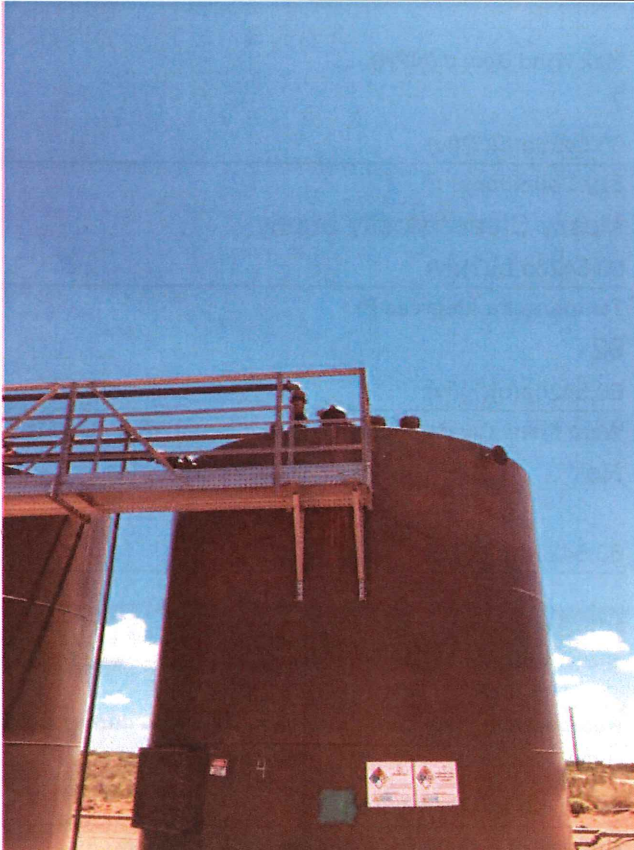
Type of Leaking Component?	Describe Leaking Component Location	Take iPhone photograph of leaking component and identify location.
Thief Hatch 60.5420a(b)(7)(vii) 60.5420a(b)(7)(viii)	Oil tank 4 thief hatch 60.5420a(c)(15)(ii)(l)(8)

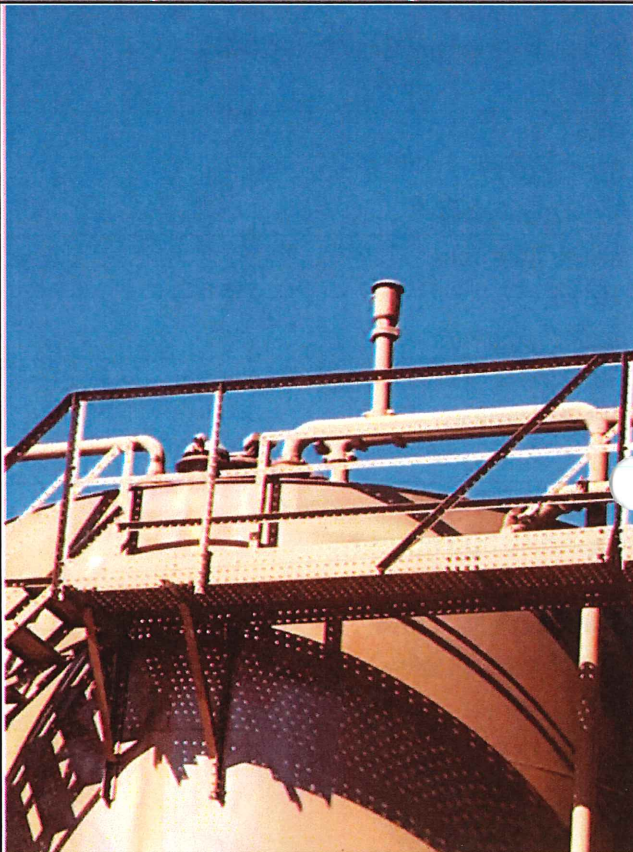
Type of Leaking Component?	Describe Leaking Component Location	Take iPhone photograph of leaking component and identify location.
Other (please describe) 60.5420a(b)(7)(vii) 60.5420a(b)(7)(viii)	Oil tank 4 tank pressure relief vent 60.5420a(c)(15)(ii)(I)(8)

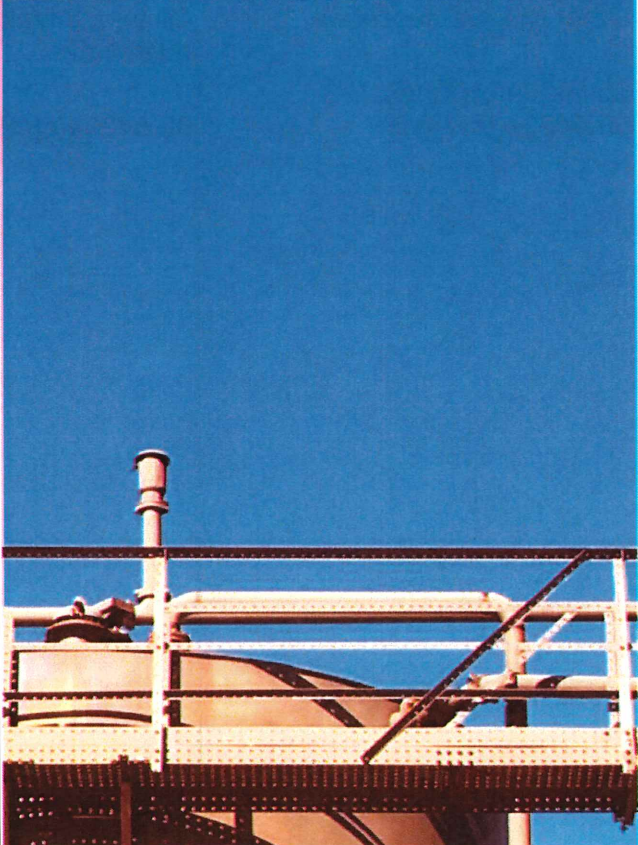
Type of Leaking Component?	Describe Leaking Component Location	Take iPhone photograph of leaking component and identify location.
Enardo Valve (PVRV) 60.5420a(b)(7)(vii) 60.5420a(b)(7)(viii)	Oil tank 3 enardo 60.5420a(c)(15)(ii)(l)(8)

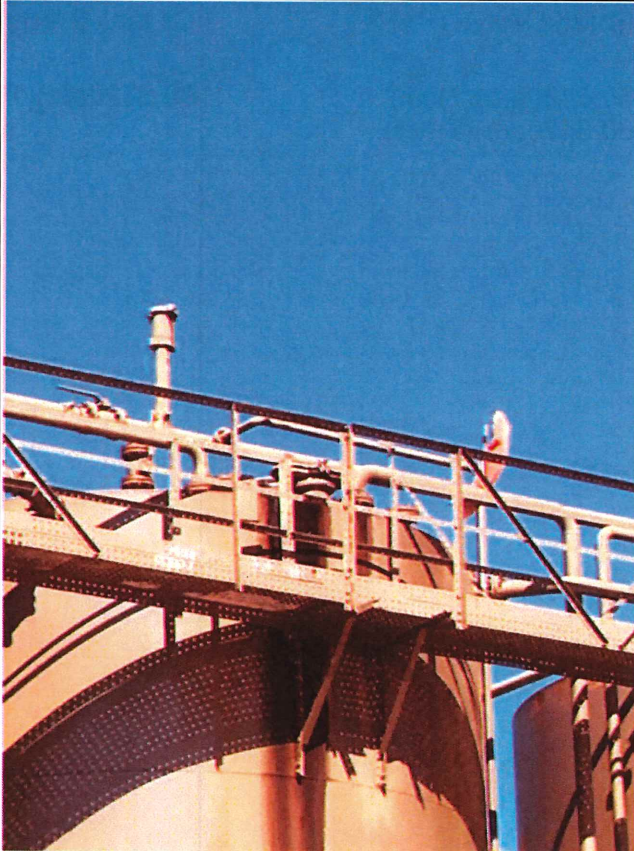
Type of Leaking Component?	Describe Leaking Component Location	Take iPhone photograph of leaking component and identify location.
Other (please describe) 60.5420a(b)(7)(vii) 60.5420a(b)(7)(viii)	Oil tank 2 pressure relief valve 60.5420a(c)(15)(ii)(I)(8)

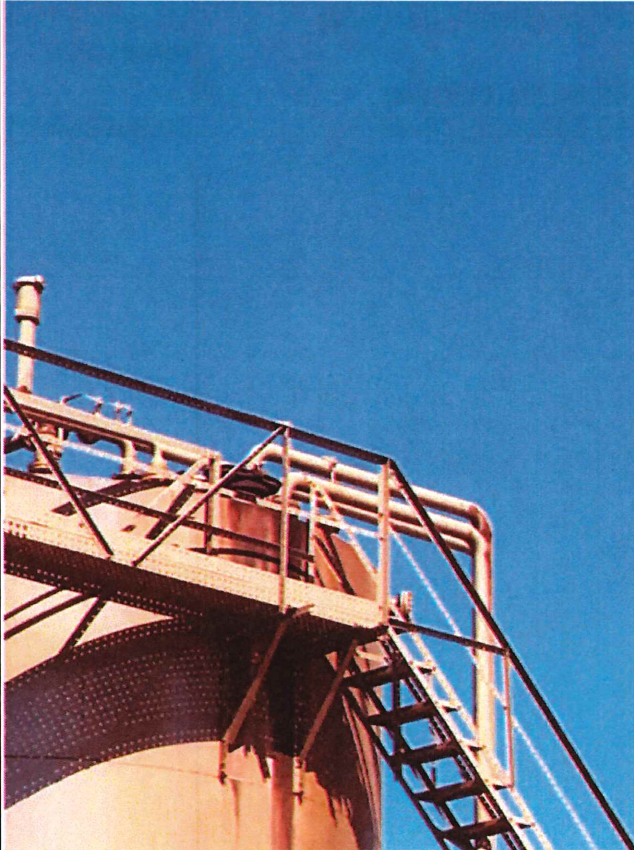
Type of Leaking Component?	Describe Leaking Component Location	Take iPhone photograph of leaking component and identify location.
Other (please describe) 60.5420a(b)(7)(vii) 60.5420a(b)(7)(viii)	Oil tank 1 tank pressure relief valve 60.5420a(c)(15)(ii)(l)(8)

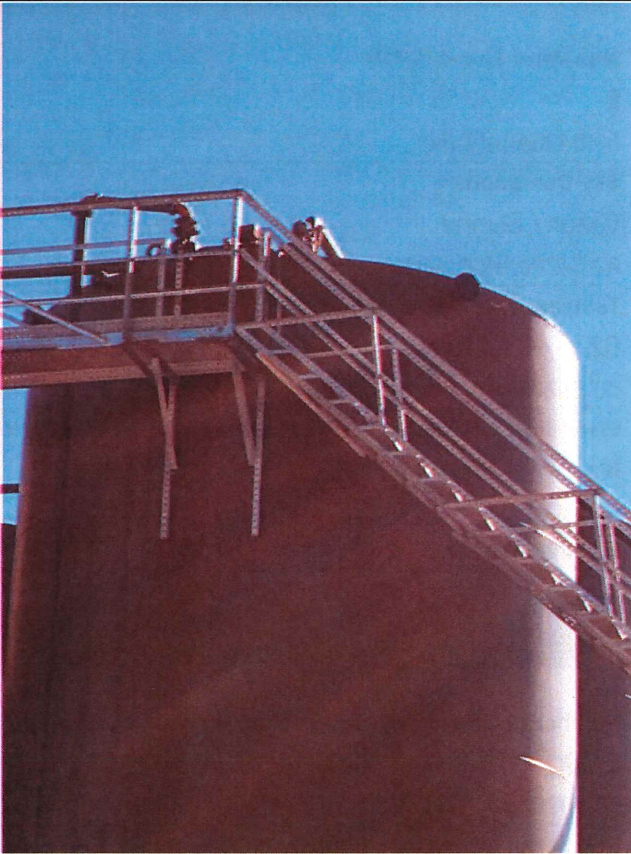
Type of Leaking Component?	Describe Leaking Component Location	Take iPhone photograph of leaking component and identify location.
Thief Hatch 60.5420a(b)(7)(vii) 60.5420a(b)(7)(viii)	Oil tank S/N 37285 tank #73006408-7 thief hatch 60.5420a(c)(15)(ii)(l)(8)

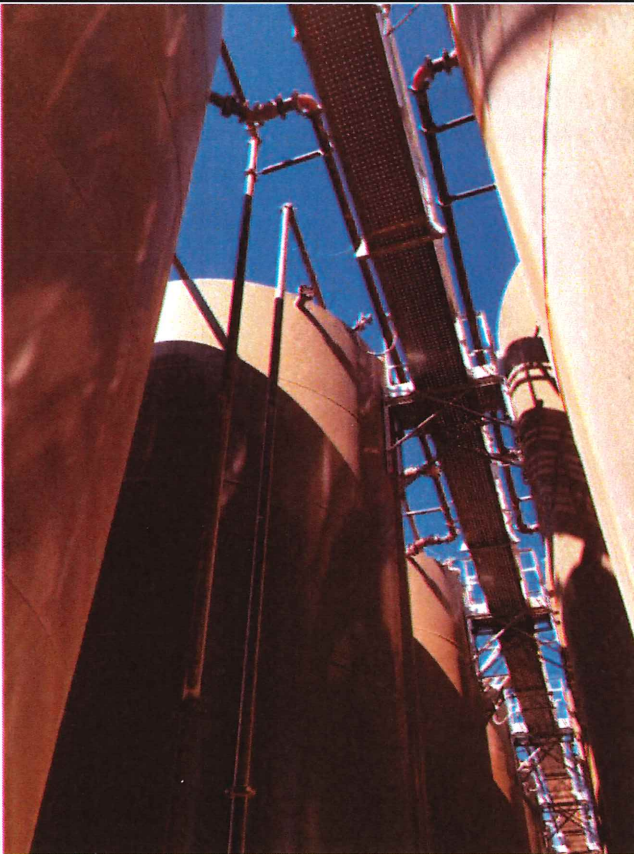
Type of Leaking Component?	Describe Leaking Component Location	Take iPhone photograph of leaking component and identify location.
Thief Hatch 60.5420a(b)(7)(vii) 60.5420a(b)(7)(viii)	Oil tank 2 thief hatch 60.5420a(c)(15)(ii)(I)(8)

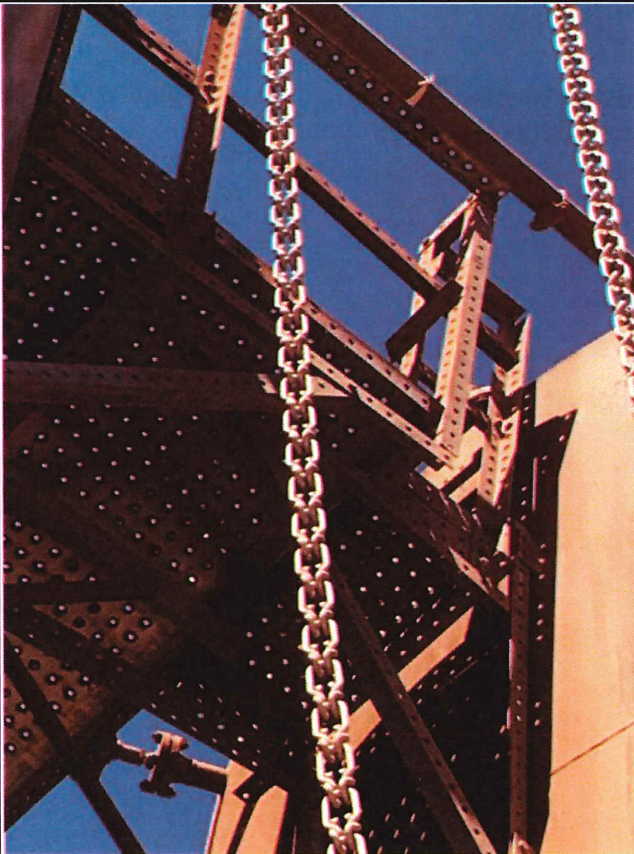
Type of Leaking Component?	Describe Leaking Component Location	Take iPhone photograph of leaking component and identify location.
Thief Hatch 60.5420a(b)(7)(vii) 60.5420a(b)(7)(viii)	Oil tank S/N 11303 north east thief hatch or tank pressure relief 60.5420a(c)(15)(ii)(l)(8)

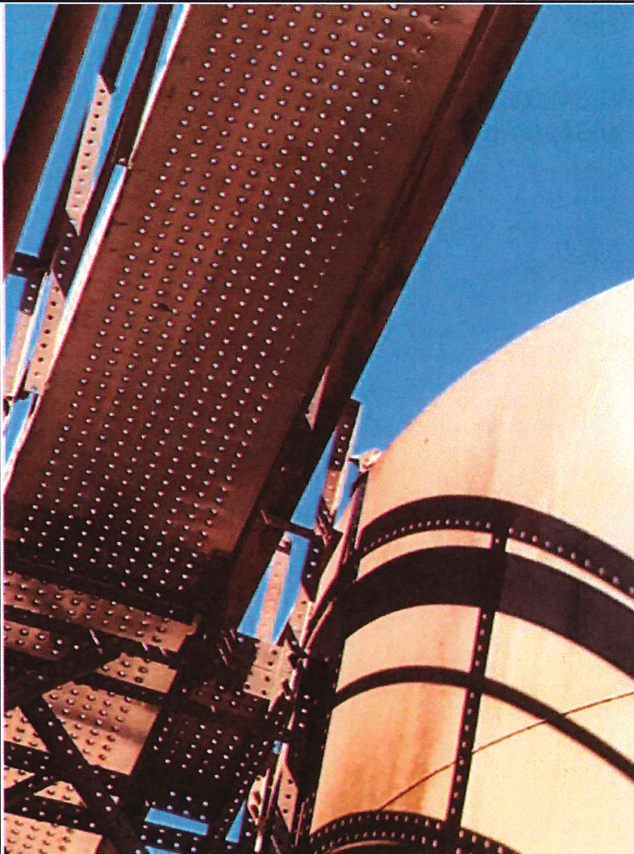
Type of Leaking Component?	Describe Leaking Component Location	Take iPhone photograph of leaking component and identify location.
Thief Hatch 60.5420a(b)(7)(vii) 60.5420a(b)(7)(viii)	Oil tank north middle thief hatch or tank pressure relief vent 60.5420a(c)(15)(ii)(I)(8)

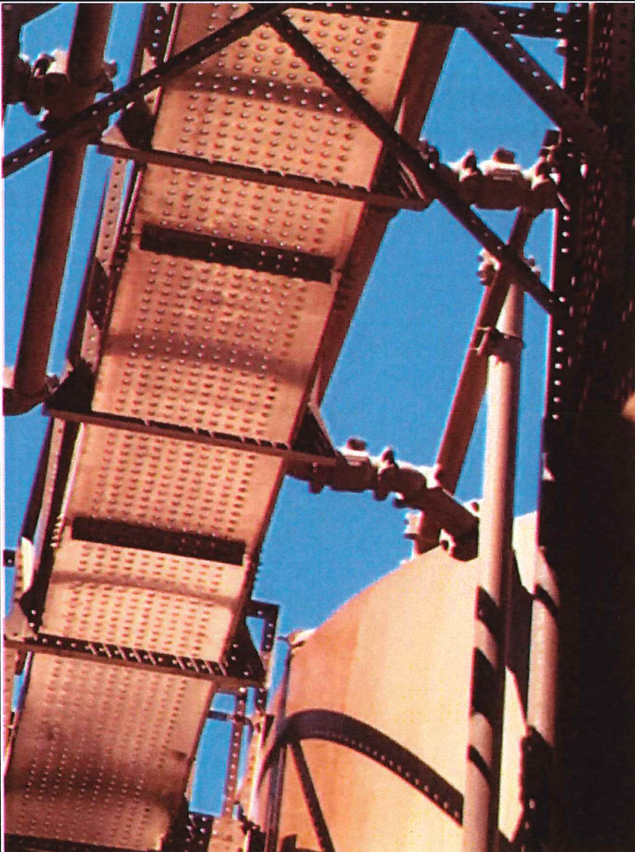
Type of Leaking Component?	Describe Leaking Component Location	Take iPhone photograph of leaking component and identify location.
Thief Hatch 60.5420a(b)(7)(vii) 60.5420a(b)(7)(viii)	Oil tank north west thief hatch or tank pressure relief vent 60.5420a(c)(15)(ii)(I)(8)

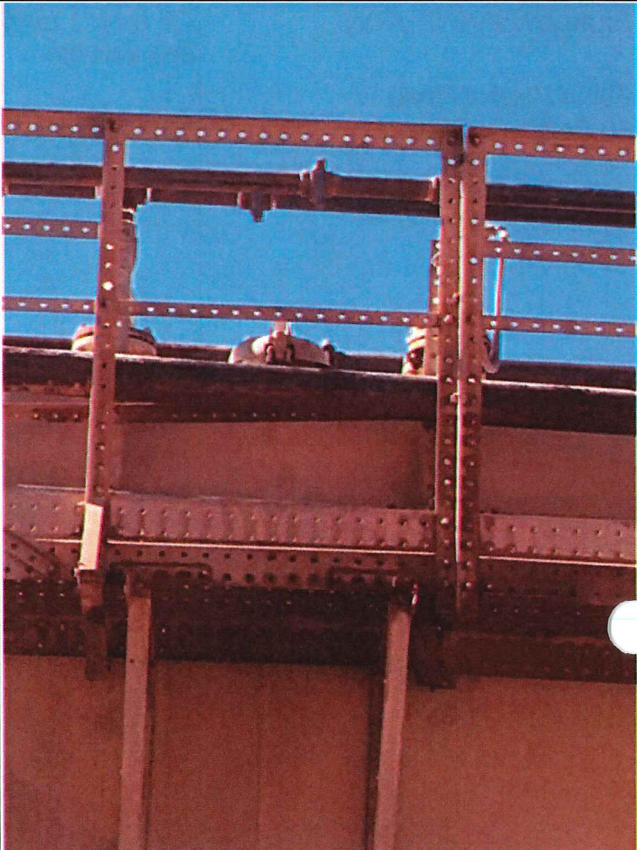
Type of Leaking Component?	Describe Leaking Component Location	Take iPhone photograph of leaking component and identify location.
Thief Hatch 60.5420a(b)(7)(vii) 60.5420a(b)(7)(viii)	Oil tank 2 thief hatch 60.5420a(c)(15)(ii)(I)(8)

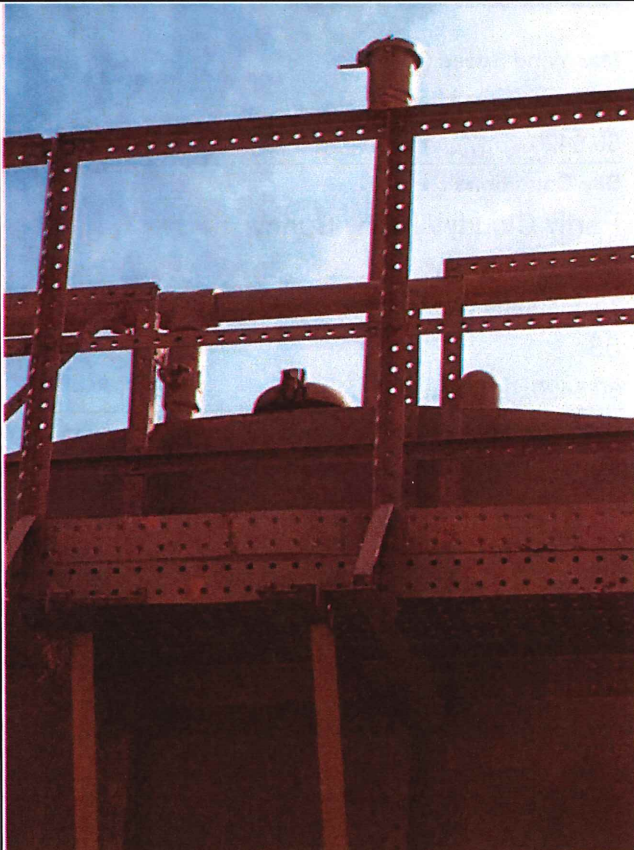
Type of Leaking Component?	Describe Leaking Component Location	Take iPhone photograph of leaking component and identify location.
Thief Hatch 60.5420a(b)(7)(vii) 60.5420a(b)(7)(viii)	Oil tank MI 303766 thief hatch 60.5420a(c)(15)(ii)(I)(8)

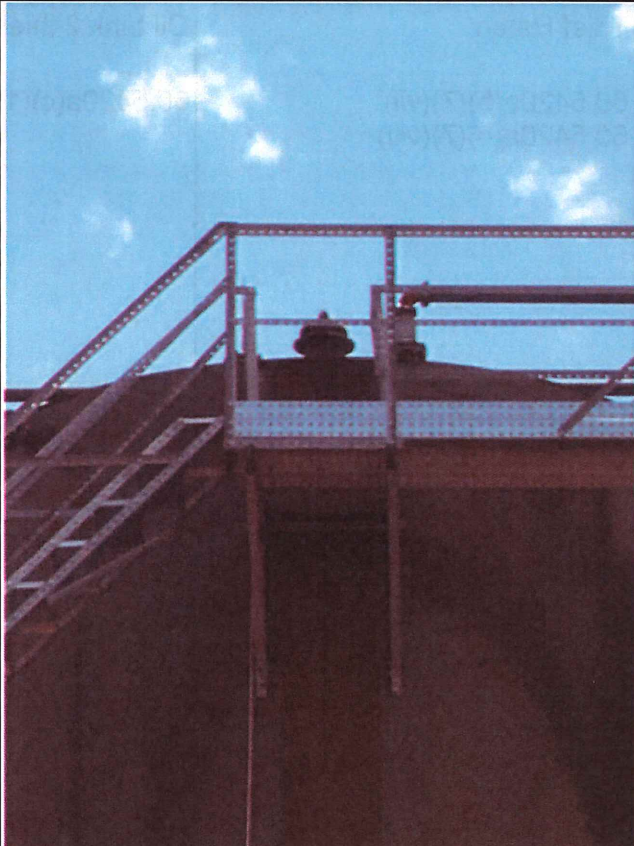
Type of Leaking Component?	Describe Leaking Component Location	Take iPhone photograph of leaking component and identify location.
Thief Hatch 60.5420a(b)(7)(vii) 60.5420a(b)(7)(viii)	Oil tank 1 thief hatch 60.5420a(c)(15)(ii)(I)(8)

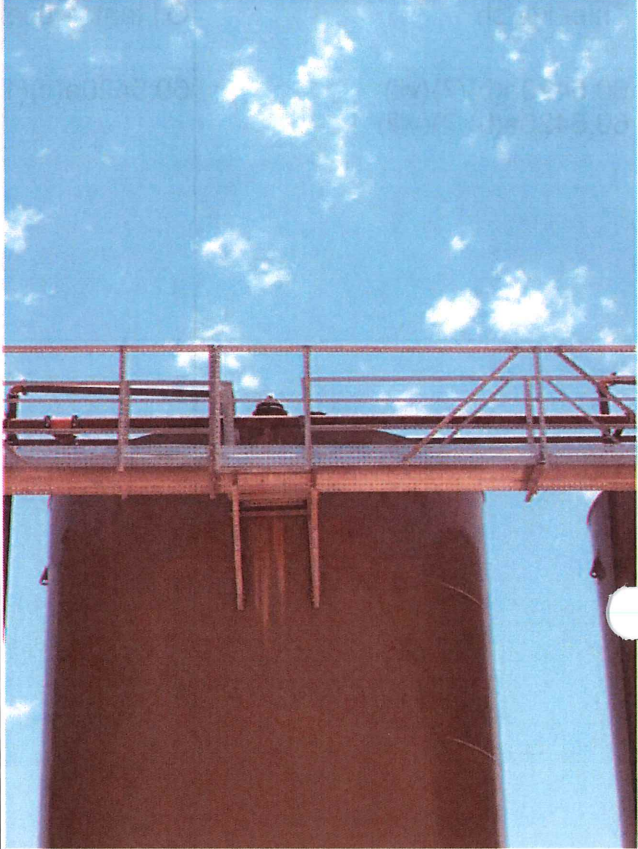
Type of Leaking Component?	Describe Leaking Component Location	Take iPhone photograph of leaking component and identify location.
Thief Hatch 60.5420a(b)(7)(vii) 60.5420a(b)(7)(viii)	Oil tank 2 thief hatch 60.5420a(c)(15)(ii)(l)(8)

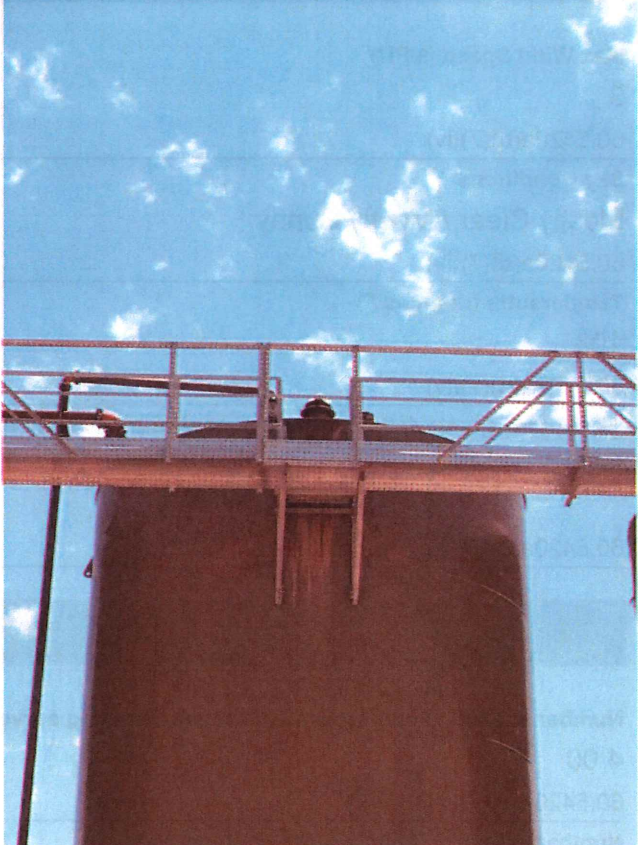
Type of Leaking Component?	Describe Leaking Component Location	Take iPhone photograph of leaking component and identify location.
Thief Hatch 60.5420a(b)(7)(vii) 60.5420a(b)(7)(viii)	Oil tank 3 thief hatch 60.5420a(c)(15)(ii)(l)(8)

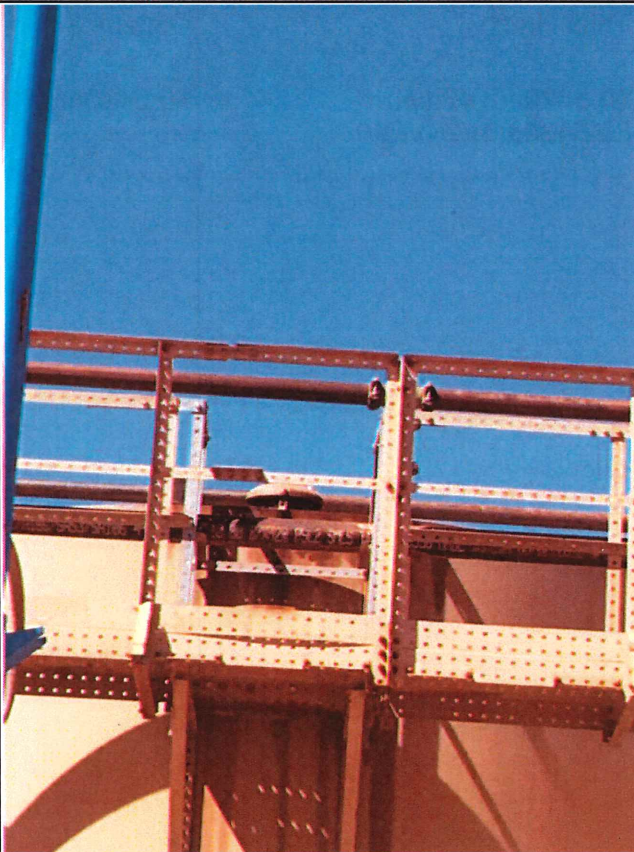
Type of Leaking Component?	Describe Leaking Component Location	Take iPhone photograph of leaking component and identify location.
Thief Hatch 60.5420a(b)(7)(vii) 60.5420a(b)(7)(viii)	Oil tank 2 thief hatch 60.5420a(c)(15)(ii)(l)(8)

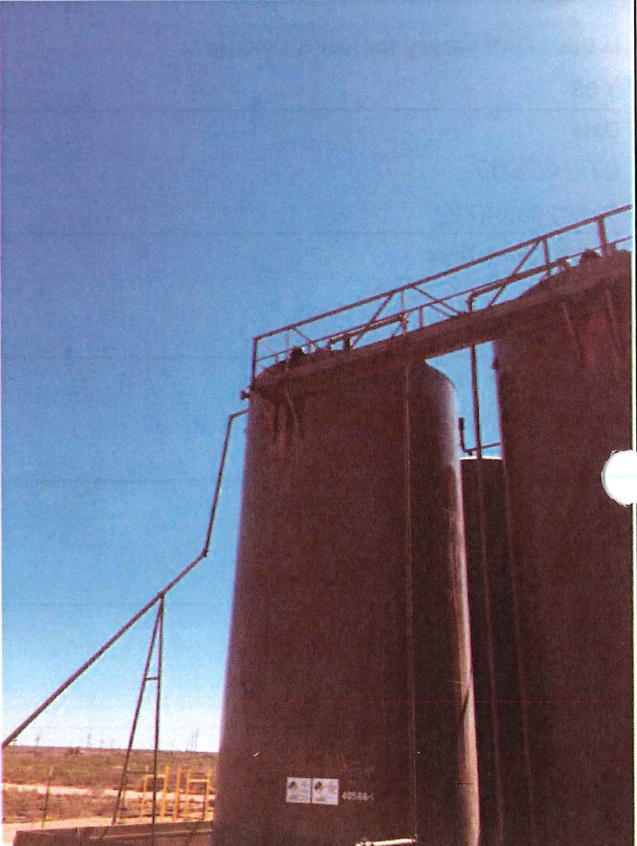
Type of Leaking Component?	Describe Leaking Component Location	Take iPhone photograph of leaking component and identify location.
Thief Hatch 60.5420a(b)(7)(vii) 60.5420a(b)(7)(viii)	Oil tank 1 thief hatch 60.5420a(c)(15)(ii)(I)(8)

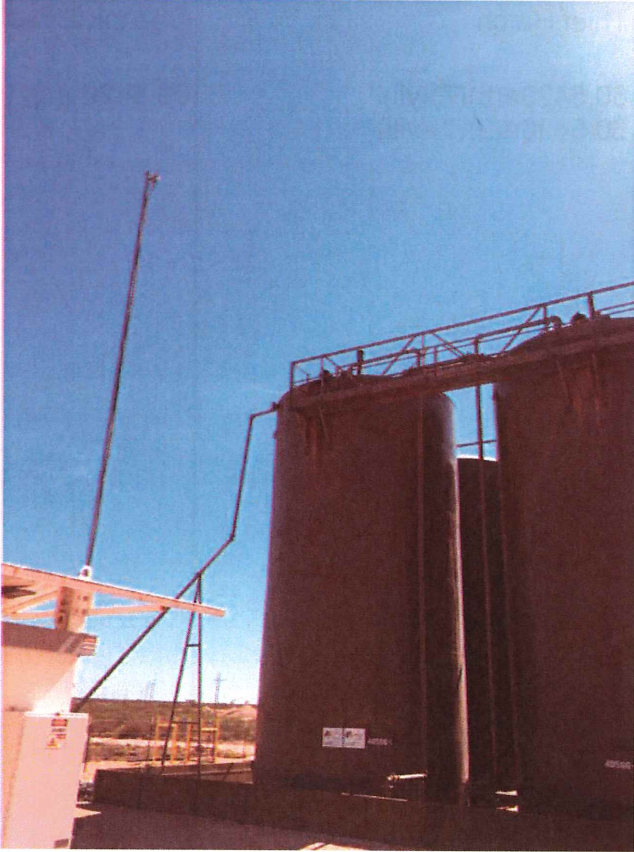
Type of Leaking Component?	Describe Leaking Component Location	Take iPhone photograph of leaking component and identify location.
Enardo Valve (PVRV) 60.5420a(b)(7)(vii) 60.5420a(b)(7)(viii)	Oil tank 1 common tank vent enardo 60.5420a(c)(15)(ii)(I)(8)

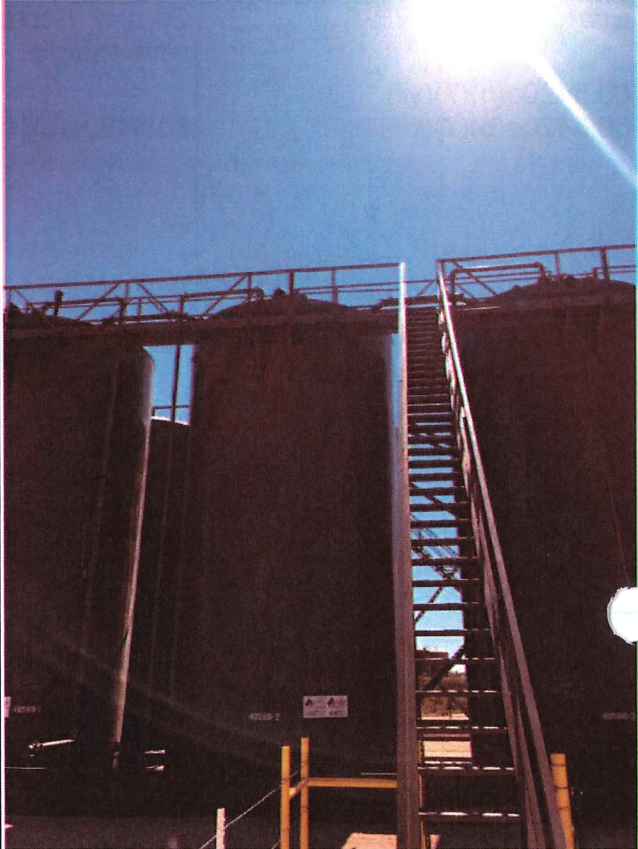
Type of Leaking Component?	Describe Leaking Component Location	Take iPhone photograph of leaking component and identify location.
Thief Hatch 60.5420a(b)(7)(vii) 60.5420a(b)(7)(viii)	Oil tank 2 thief hatch 60.5420a(c)(15)(ii)(I)(8)

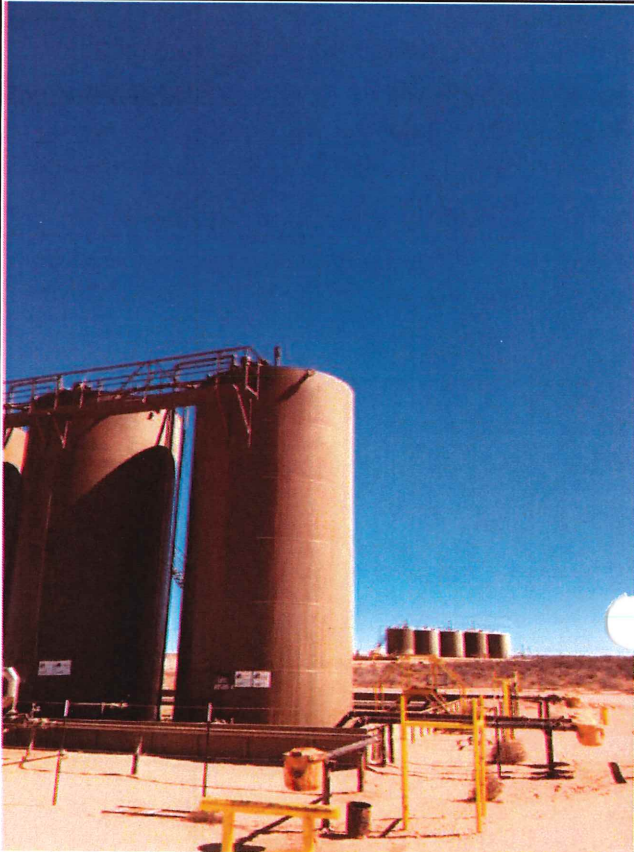
Type of Leaking Component?	Describe Leaking Component Location	Take iPhone photograph of leaking component and identify location.
Thief Hatch 60.5420a(b)(7)(vii) 60.5420a(b)(7)(viii)	Oil tank 4 thief hatch 60.5420a(c)(15)(ii)(I)(8)

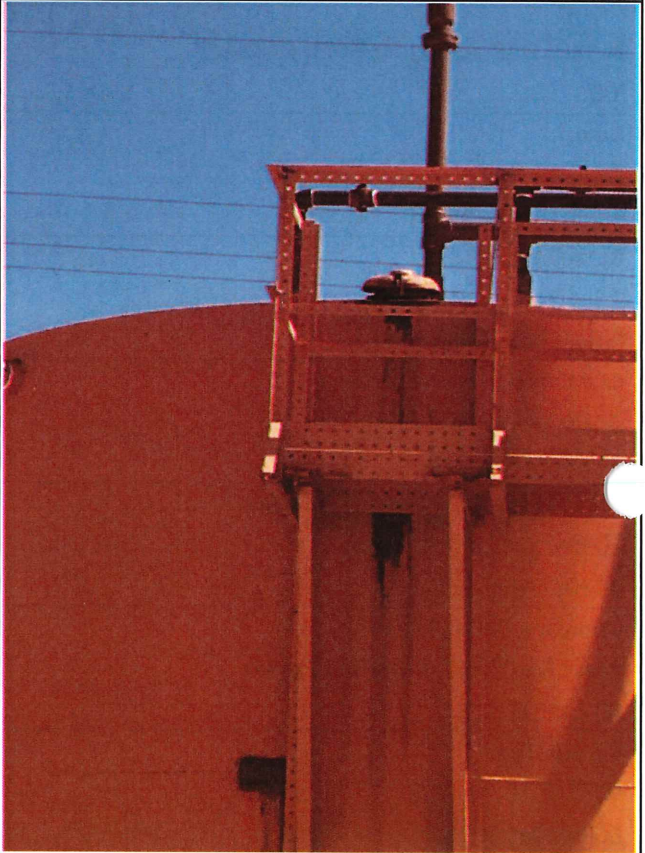
Type of Leaking Component?	Describe Leaking Component Location	Take iPhone photograph of leaking component and identify location.
Thief Hatch 60.5420a(b)(7)(vii) 60.5420a(b)(7)(viii)	Oil tank 1 MI 278788 thief hatch 60.5420a(c)(15)(ii)(I)(8)

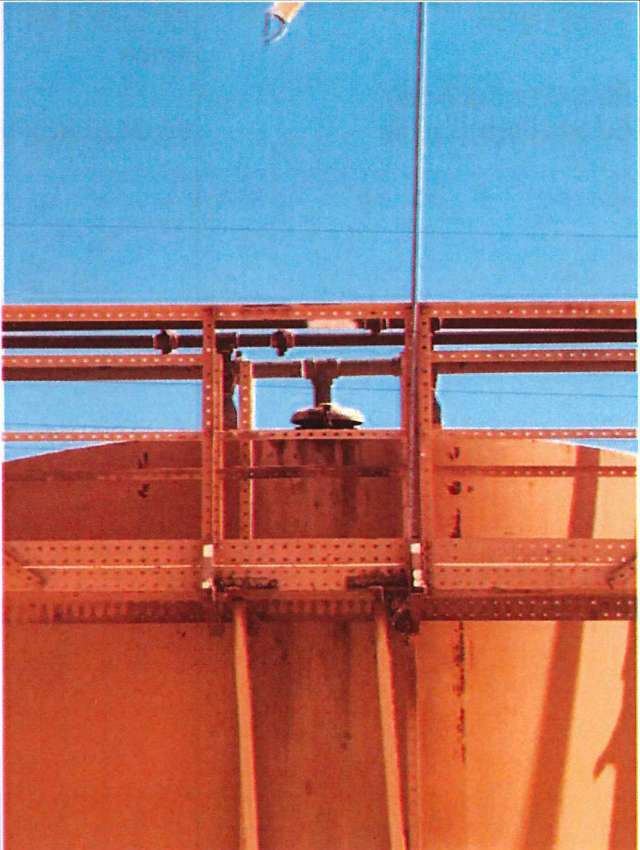
Type of Leaking Component?	Describe Leaking Component Location	Take iPhone photograph of leaking component and identify location.
Thief Hatch 60.5420a(b)(7)(vii) 60.5420a(b)(7)(viii)	Oil tank 2 MI. Thief hatch 60.5420a(c)(15)(ii)(l)(8)

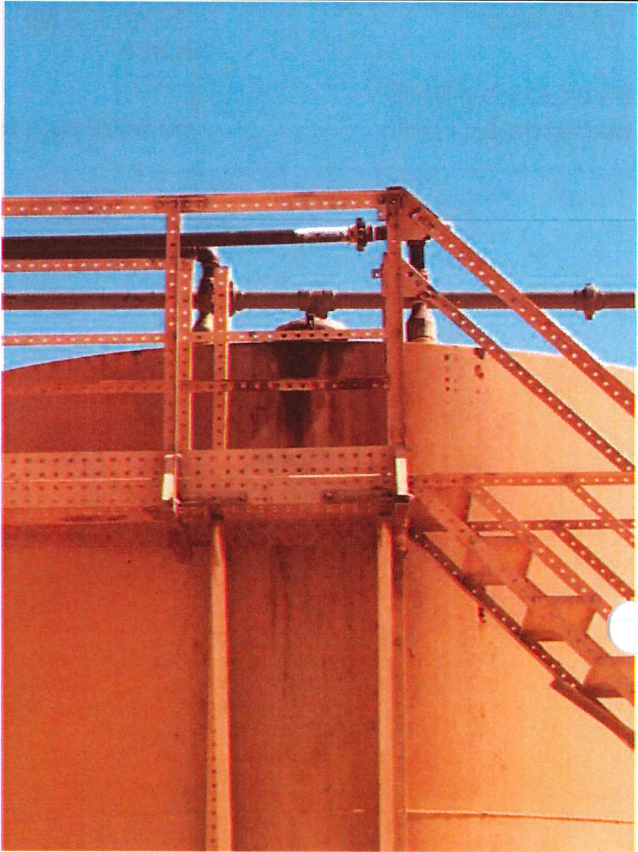
Type of Leaking Component?	Describe Leaking Component Location	Take iPhone photograph of leaking component and identify location.
Thief Hatch 60.5420a(b)(7)(vii) 60.5420a(b)(7)(viii)	Oil tank 3 MI. Thief hatch 60.5420a(c)(15)(ii)(l)(8)

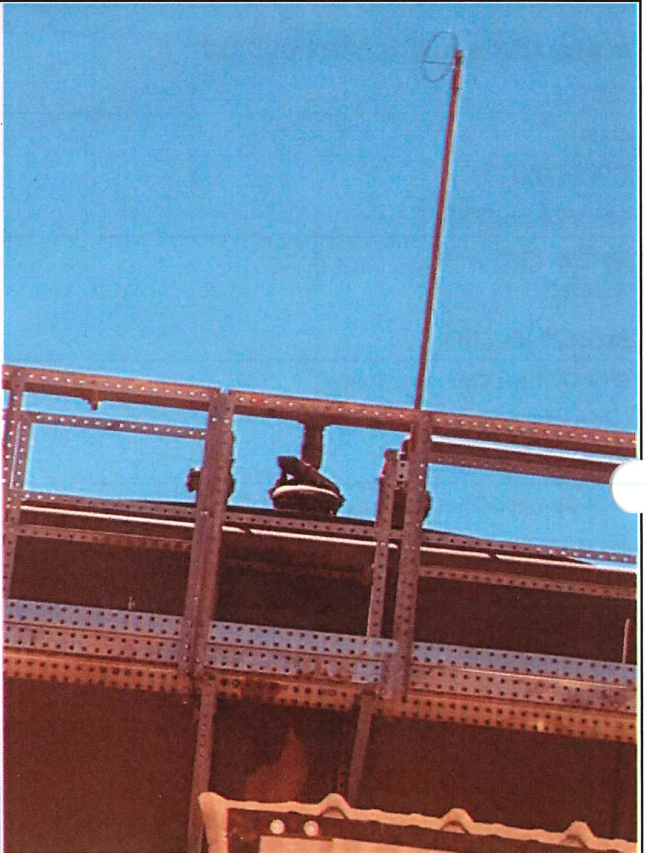
Type of Leaking Component?	Describe Leaking Component Location	Take iPhone photograph of leaking component and identify location.
Thief Hatch 60.5420a(b)(7)(vii) 60.5420a(b)(7)(viii)	Oil tank 2 thief hatch 60.5420a(c)(15)(ii)(l)(8)

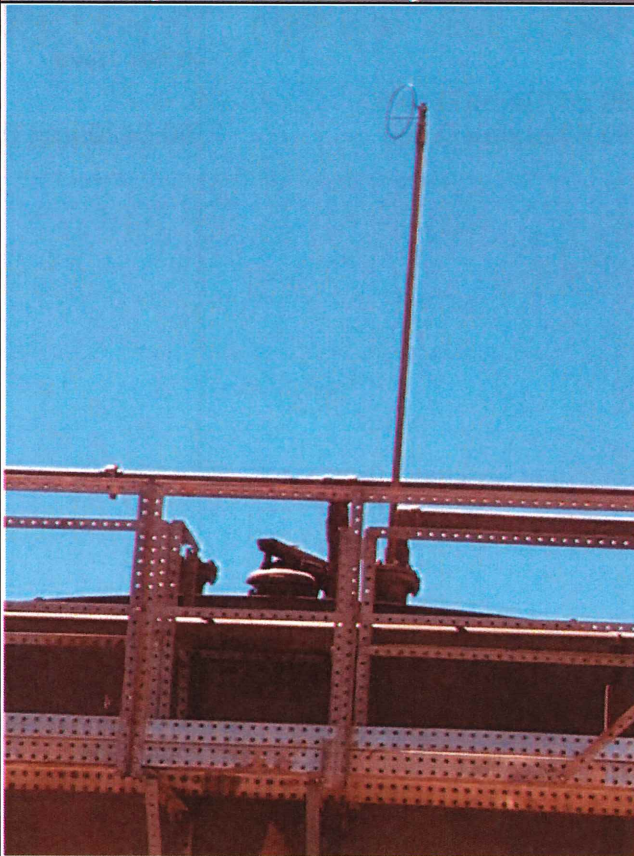
Type of Leaking Component?	Describe Leaking Component Location	Take iPhone photograph of leaking component and identify location.
Pressure Safety Valve (PSV) 60.5420a(b)(7)(vii) 60.5420a(b)(7)(viii)	Oil tank 2 tank pressure relief valve 60.5420a(c)(15)(ii)(l)(8)

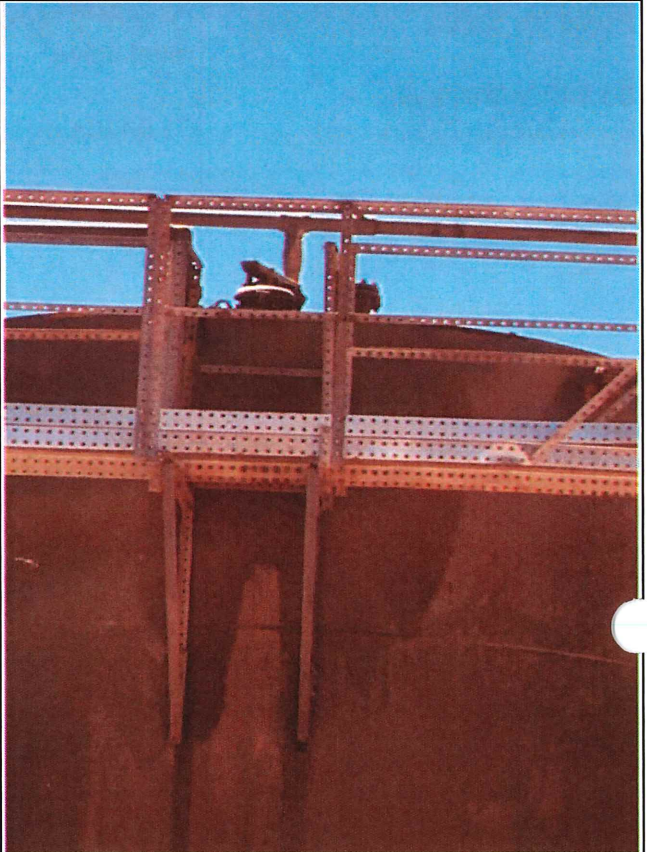
Type of Leaking Component?	Describe Leaking Component Location	Take iPhone photograph of leaking component and identify location.
Pressure Safety Valve (PSV) 60.5420a(b)(7)(vii) 60.5420a(b)(7)(viii)	Oil tank 3 tank pressure relief valve 60.5420a(c)(15)(ii)(l)(8)

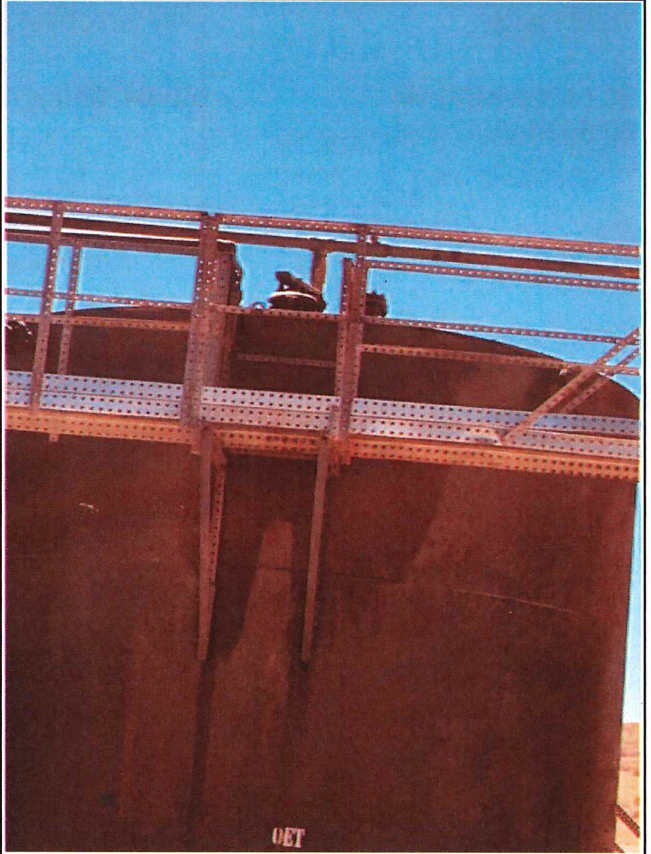
Type of Leaking Component?	Describe Leaking Component Location	Take iPhone photograph of leaking component and identify location.
Thief Hatch 60.5420a(b)(7)(vii) 60.5420a(b)(7)(viii)	Oil tank 3 thief hatch 60.5420a(c)(15)(ii)(I)(8)

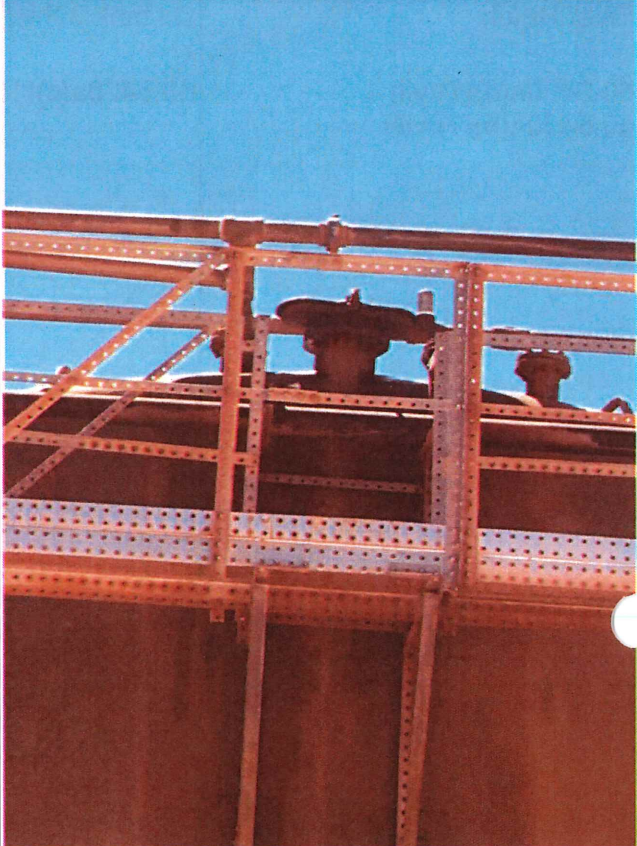
Type of Leaking Component?	Describe Leaking Component Location	Take iPhone photograph of leaking component and identify location.
Thief Hatch 60.5420a(b)(7)(vii) 60.5420a(b)(7)(viii)	PW tank thief hatch 60.5420a(c)(15)(ii)(I)(8)

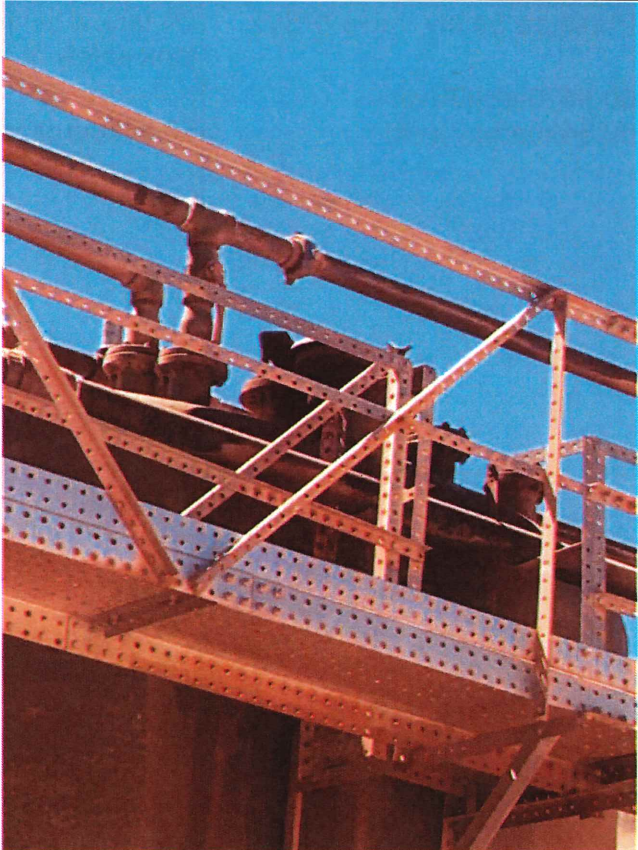
Type of Leaking Component?	Describe Leaking Component Location	Take iPhone photograph of leaking component and identify location.
Pressure Safety Valve (PSV) 60.5420a(b)(7)(vii) 60.5420a(b)(7)(viii)	PW tank 2 tank safety relief valve 60.5420a(c)(15)(ii)(l)(8)

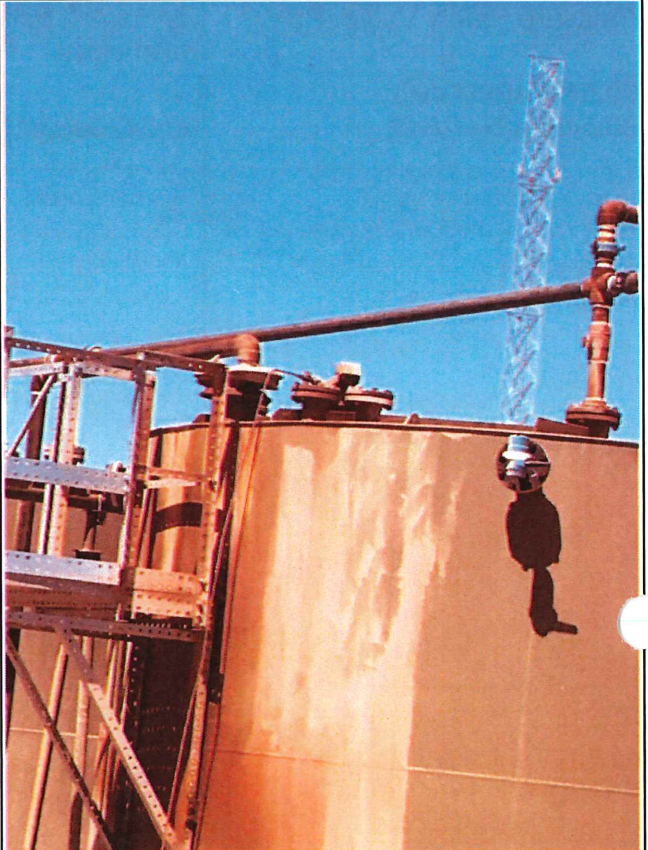
Type of Leaking Component?	Describe Leaking Component Location	Take iPhone photograph of leaking component and identify location.
Pressure Safety Valve (PSV) 60.5420a(b)(7)(vii) 60.5420a(b)(7)(viii)	Oil tank 4 behind tank1 tank safety relief valve 60.5420a(c)(15)(ii)(I)(8)

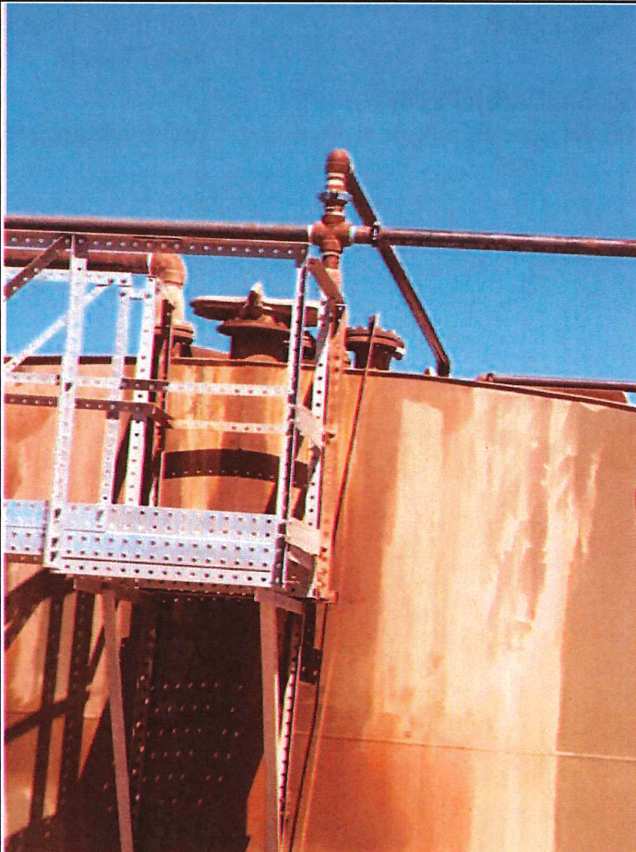
Type of Leaking Component?	Describe Leaking Component Location	Take iPhone photograph of leaking component and identify location.
Thief Hatch 60.5420a(b)(7)(vii) 60.5420a(b)(7)(viii)	Oil tank 4 thief hatch 60.5420a(c)(15)(ii)(I)(8)

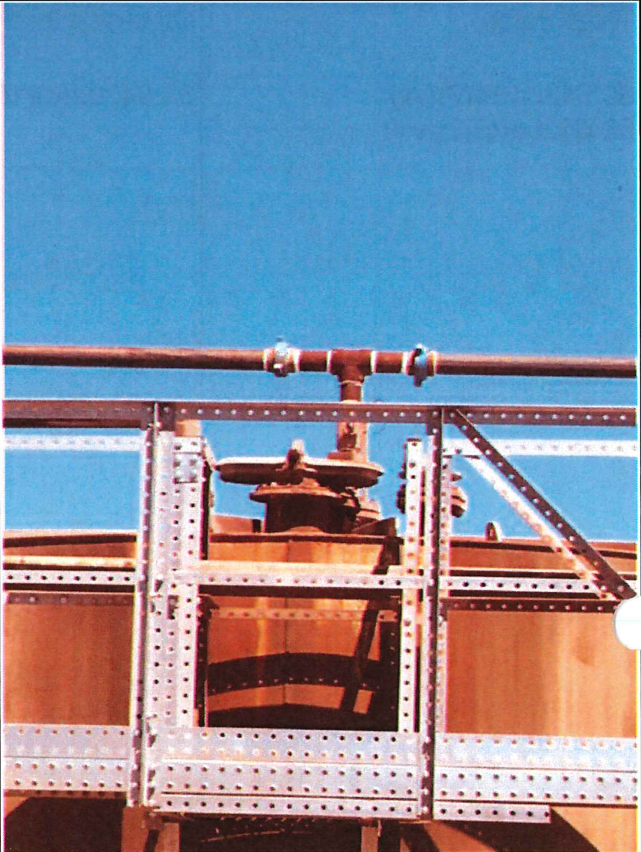
Type of Leaking Component?	Describe Leaking Component Location	Take iPhone photograph of leaking component and identify location.
Thief Hatch 60.5420a(b)(7)(vii) 60.5420a(b)(7)(viii)	Oil tank 5 behind tank 2 thief hatch 60.5420a(c)(15)(ii)(l)(8)

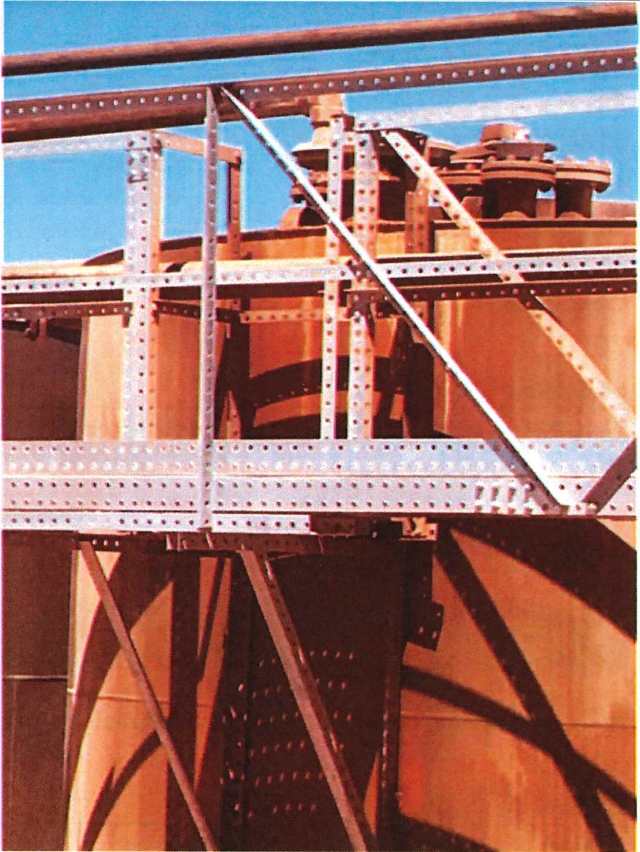
Type of Leaking Component?	Describe Leaking Component Location	Take iPhone photograph of leaking component and identify location.
Pressure Safety Valve (PSV) 60.5420a(b)(7)(vii) 60.5420a(b)(7)(viii)	Oil tank 5 tank pressure relief valve 60.5420a(c)(15)(ii)(l)(8)
